**Flood Control Project Maintenance
Levee Inspections**

Fall 2019 Levee Maintenance Deficiency Summary Report

RD0784	Overall LMA Rating	Total LMA Miles							
Reclamation District No. 0784 Plumas Lake	A	33.20							
Rated Item	Maintenance Deficiency				Enforcement		Design & System Obsolescence		
	M Miles	U Miles	M + 4U Miles	Threshold %	M Miles	U Miles	M Miles	U Miles	
<i>Earthen Levee</i>									
Encroachments					2.58	0.49			
<i>Supplemental</i>									
DRAFT DWR UCIP Field Study					0.02				
DRAFT DWR UCIP LMA Responsibility									
<i>LMA Totals:</i>	0.00	0.00	0.00	0.00%	2.60	0.49	0.00	0.00	
Unit No. 01 Yuba River LB	Overall Unit Rating	Total Unit Miles							
RD0784	A	2.21							
Rated Item	Maintenance Deficiency				Enforcement		Design & System Obsolescence		
	M Miles	U Miles	M + 4U Miles	Threshold %	M Miles	U Miles	M Miles	U Miles	
<i>Earthen Levee</i>									
Encroachments						0.49			
<i>Supplemental</i>									
DRAFT DWR UCIP Field Study					0.01				
<i>Unit Totals:</i>	0.00	0.00	0.00	0.00%	0.01	0.49	0.00	0.00

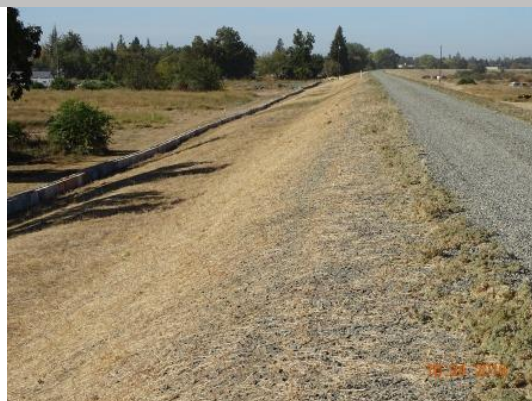
Photo 1 of 1 : FA_2019_RD0784_178_2_20191029_00007.jpg

View looking downstream landside at the well maintained annual vegetation, Fall 2019.

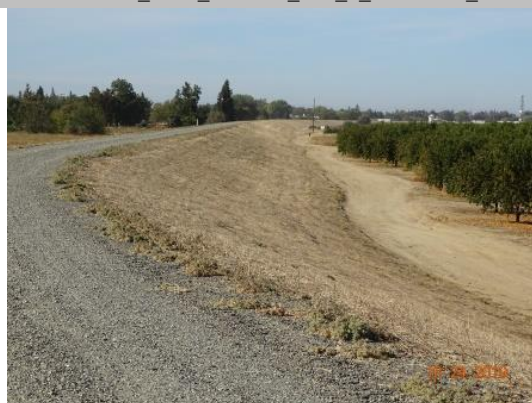
Photo 1 of 1 : FA_2019_RD0784_178_3_20191029_00006.jpg

LM Start	0.04	Rating **	A	Issue No.	3
LM End	2.20	Issue Type +	Ma	Location *	WS
Category	Earthen Levee			GPS Latitude/Longitude	
				Start	End
Item	Vegetation			39.134434 °	39.125913 °
				-121.552677 °	-121.588648 °
DWR ID	DWR_RD0784_01_f_2019_3				
Comment Code					
V1 : Control annual grass and weeds on the levee slopes and easements.					
Inspector Comment					
The annual vegetation is well maintained, Fall 2019.

View looking downstream waterside at the well maintained annual vegetation, Fall 2019.

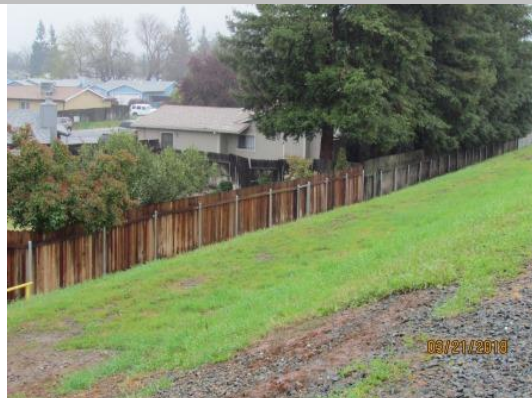
Photo 1 of 1 : FA_2019_RD0784_178_12_20190904_00001.jpg

LM Start	0.51	Rating **	U	Issue No.	12
LM End	1.00	Issue Type +	En	Location *	LS
Category	Earthen Levee			GPS Latitude/Longitude	
				Start	End
Item	Encroachments			39.131558 °	39.129475 °
				-121.560668 °	-121.569209 °
DWR ID	DWR_RD0784_01_f_2012_12				
Comment Code					
FE : Fence					
Inspector Comment					
Fences are found within the 10 feet of levee easement.

View looking downstream landside of fences that are found on the landside toe of the levee looking downstream.

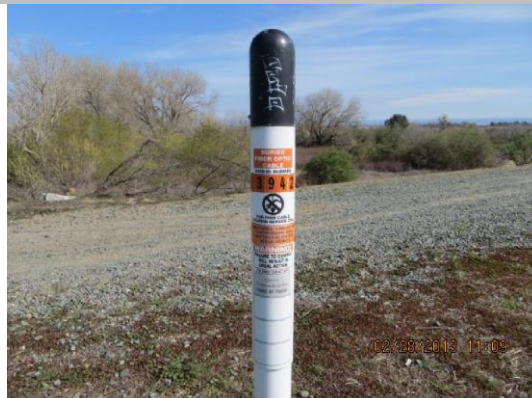
Photo 1 of 3 : UCIP_FA_2019_50677_54402.jpg

Comment Code						
Inspector Comment						
DS_ID:18552 FS_ID:50677 EP_NO: N/A Repair Type: Non-Urgent Crossing Status: Indicator Found UCIP Comments: 11/15/2016 - Crossing is still Non-Urgent due to the possibility that the pipe is unpermitted. The crossing will be downgraded when owner provides permit or CVFPB enforcement resolves the issue. (DWR UCIP - thatch)11/01/2015 - Letter requesting permit or to provide permit sent to owner Century Link, 700 W. Mineral Avenue, Rm D 27.34, Littleton, CO 80120 on 2/18/2014. Pending CVFPB enforcement on utility crossing owner. Requesting DWR inspector to change the status of this issue to "No Action Needed" (P. Meagher - RD784) 02/28/2013 - No permit identified for this crossing. Need to determine if owner has permit. (W.Wylie UCIP Inspector). FIELD_STRUCT_DESC: Fiber optics communications lines of an unknown material and diameter through the levee, at an unknown depth. [Additional Reference(s): DWR Levee Log, 2005]. FS Date: 9/11/2015 9:08:00 AM

Marker on east side of Rail/WS of Levee.

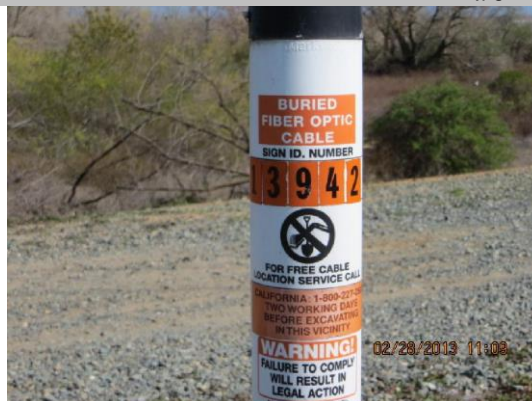
Photo 2 of 3 : UCIP_FA_2019_50677_54401.jpg

Marker on east side of Rail/WS of Levee.

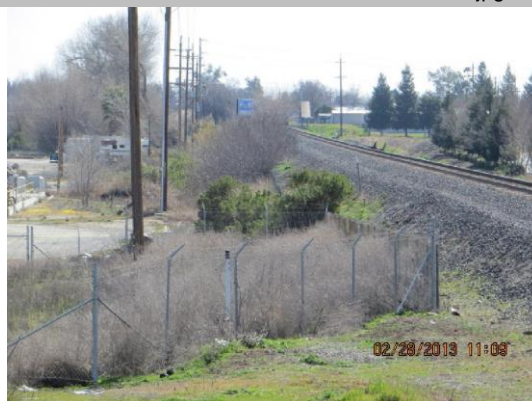
Photo 3 of 3 : UCIP_FA_2019_50677_54400.jpg

Comment Code						
Inspector Comment						
DS_ID:18552 FS_ID:50677 EP_NO: N/A Repair Type: Non-Urgent Crossing Status: Indicator Found UCIP Comments: 11/15/2016 - Crossing is still Non-Urgent due to the possibility that the pipe is unpermitted. The crossing will be downgraded when owner provides permit or CVFPB enforcement resolves the issue. (DWR UCIP - thatch)11/01/2015 - Letter requesting permit or to provide permit sent to owner Century Link, 700 W. Mineral Avenue, Rm D 27.34, Littleton, CO 80120 on 2/18/2014. Pending CVFPB enforcement on utility crossing owner. Requesting DWR inspector to change the status of this issue to "No Action Needed" (P. Meagher - RD784) 02/28/2013 - No permit identified for this crossing. Need to determine if owner has permit. (W.Wylie UCIP Inspector). FIELD_STRUCT_DESC: Fiber optics communications lines of an unknown material and diameter through the levee, at an unknown depth. [Additional Reference(s): DWR Levee Log, 2005]. FS Date: 9/11/2015 9:08:00 AM

Marker on East side of Rail/LS of levee.

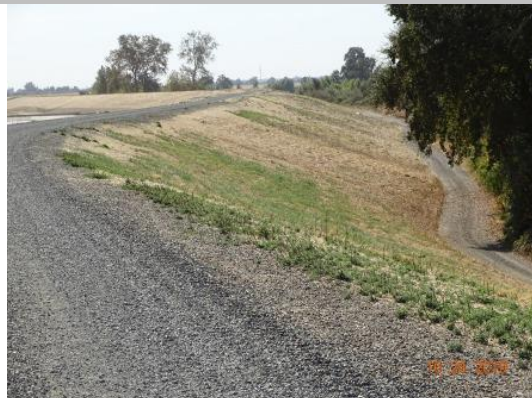
Photo 1 of 1 : FA_2019_RD0784_531_2_20191029_00001.jpg

View looking downstream waterside at the well maintained annual vegetation, Fall 2019.

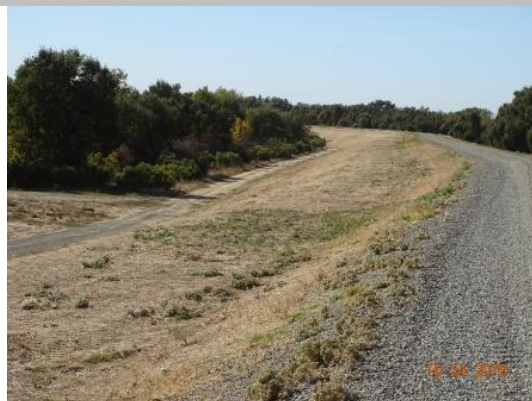
Photo 1 of 1 : FA_2019_RD0784_531_1_20191029_00002.jpg

LM Start	0.02	Rating **	A	Issue No.	1
LM End	2.52	Issue Type +	Ma	Location *	LS
Category	Earthen Levee			GPS Latitude/Longitude	
				Start	End
Item	Vegetation			39.125604 °	39.090532 °
				-121.588668 °	-121.584676 °
DWR ID	DWR_RD0784_02A_f_2019_1				
Comment Code					
V1 : Control annual grass and weeds on the levee slopes and easements.					
Inspector Comment					
The annual vegetation is well maintained, Fall 2019.

View looking downstream landside at the well maintained annual vegetation, Fall 2019.

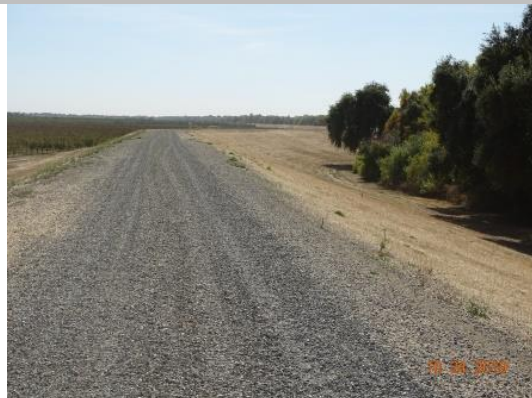
Photo 1 of 1 : FA_2019_RD0784_532_3_20191029_00004.jpg

View looking downstream waterside at the well maintained annual vegetation, Fall 2019.

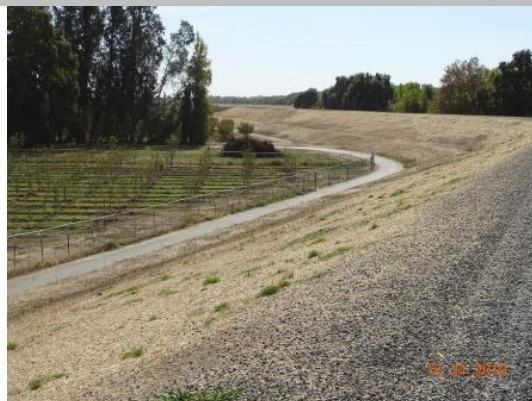
Photo 1 of 1 : FA_2019_RD0784_532_2_20191029_00003.jpg

LM Start	8.96	Rating **	A	Issue No.	2
LM End	12.81	Issue Type +	Ma	Location *	LS
Category	Earthen Levee			GPS Latitude/Longitude	
				Start	End
Item	Vegetation			39.009978 °	38.955286 °
				-121.579274 °	-121.574941 °
DWR ID	DWR_RD0784_02B_f_2019_2				
Comment Code					
V1 : Control annual grass and weeds on the levee slopes and easements.					
Inspector Comment					
The annual vegetation is well maintained, Fall 2019.

View looking downstream landside at the well maintained annual vegetation, Fall 2019.

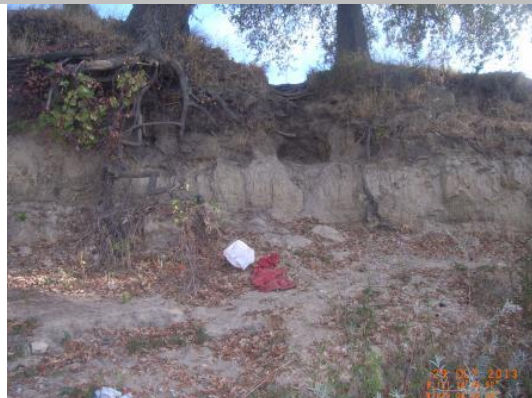
Photo 1 of 1 : FA_2019_RD0784_532_1_20190904_00001.jpg

Comment Code					
Inspector Comment					
2017 Site ID: FHR 17.8 L					
Status: Eroding					
2017 Field Notes: Large sandbar on opposite bank, thalweg moving closer to levee.					
Site History: 2003 - Bank is near vertical. Identified as a Potentially Critical site. 2004 - Eddy flow off downstream end of Modesto formation eroding the fluvial sediments. 2005 - Some new slumping. Actively eroding but berm width is greater than 50 ft. 2006 - Downgraded to regular erosion site. Still actively eroding. Large old rotational failures in high bank on the downstream end. 2008 - Removed from inventory due to wide berm width does not meet criteria for an erosion site. 2010 - Added back to the inventory after 10 ft of bank erosion in the winter 2009 storm. Steep vertical face. 2011 - Bank has retreated an additional 2.5 ft from last year. New tree popouts and erosion throughout the site. 2012 - Site continues to worsen with new tree popouts and many sections of new erosion.

USACE 2013 Photo #1

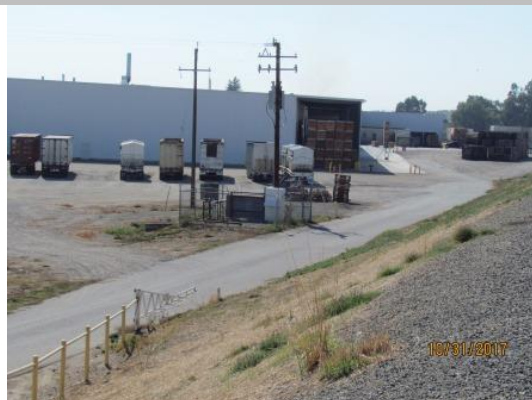
Photo 1 of 1 : FA_2019_RD0784_532_6_20190904_00002.jpg

LM Start	9.21	Rating **	M	Issue No.	6
LM End	9.31	Issue Type +	En	Location *	LS
Category	Earthen Levee			GPS Latitude/Longitude	
				Start	End
Item	Encroachments			39.006523 °	39.005235 °
				-121.577843 °	-121.578286 °
DWR ID	DWR_RD0784_02_f_2012_6				
Comment Code					
MA : Material					
Inspector Comment					
Un-permitted paving at levee toe.

View looking downstream on the landside of un-permitted paving.

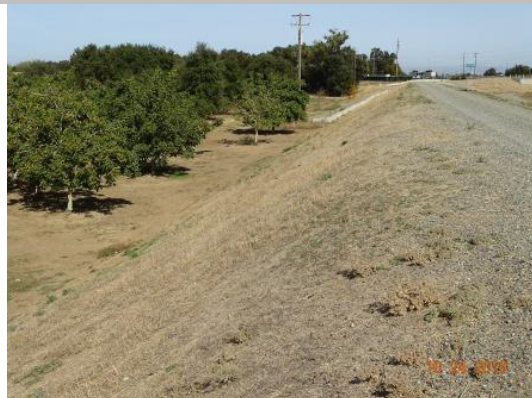
Photo 1 of 1 : FA_2019_RD0784_533_1_20191029_00002.jpg

View looking downstream landside at the well maintained annual vegetation, Fall 2019.

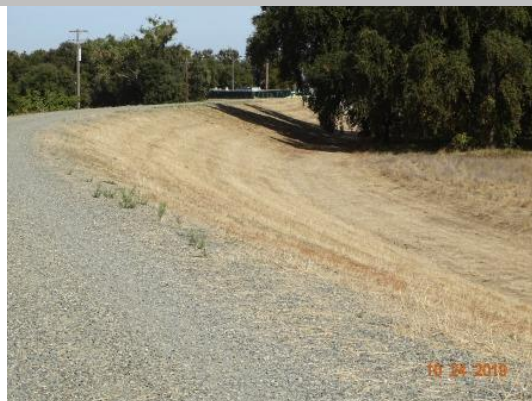
Photo 1 of 1 : FA_2019_RD0784_533_2_20191029_00003.jpg

LM Start	2.43	Rating **	A	Issue No.	2
LM End	3.19	Issue Type +	Ma	Location *	WS
Category	Earthen Levee			GPS Latitude/Longitude	
				Start	End
Item	Vegetation			38.970638 °	38.974693 °
				-121.547534 °	-121.535498 °
DWR ID	DWR_RD0784_03A_f_2019_2				
Comment Code					
V1 : Control annual grass and weeds on the levee slopes and easements.					
Inspector Comment					
The annual vegetation is well maintained, Fall 2019.

View looking downstream waterside at the well maintained annual vegetation, Fall 2019.

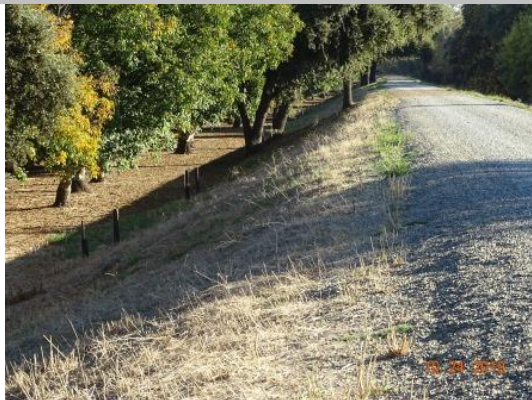
Photo 1 of 1 : FA_2019_RD0784_534_4_20191029_00005.jpg

View looking downstream landside at the well maintained annual vegetation, Fall 2019.

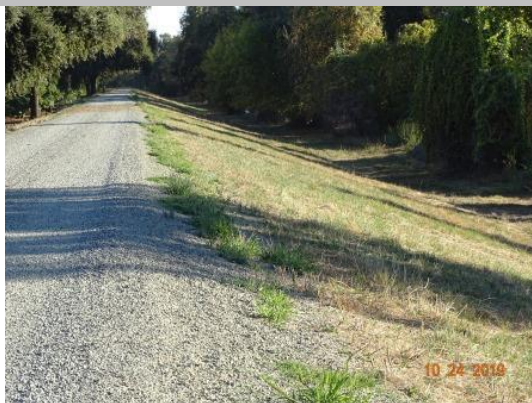
Photo 1 of 1 : FA_2019_RD0784_534_5_20191029_00006.jpg

View looking downstream waterside at the well maintained annual vegetation, Fall 2019.

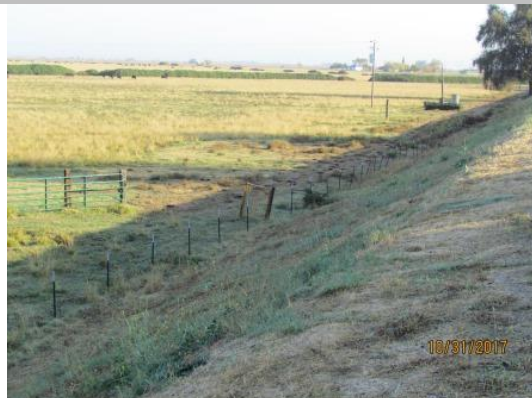
Photo 1 of 1 : FA_2019_RD0784_534_7_20190904_00001.jpg

View looking upstream landside of a fence that is at the levee toe.

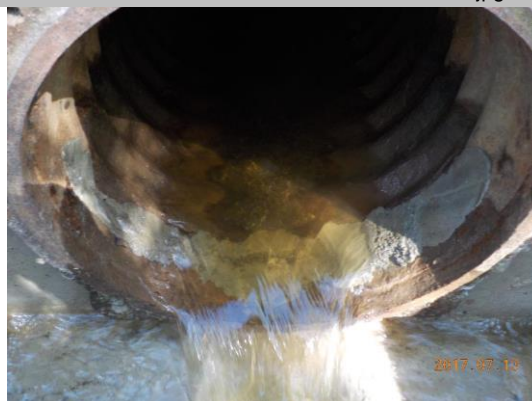
Photo 1 of 3 : UCIP_FA_2019_53072_77114.jpg

UCIP Comments: 10/16/2018 Internal video inspection was completed recently and the inspection is being evaluated by the District Engineer. Waiting for internal inspection results to determine the internal condition of this crossing. Crossing remains Urgent due to the unknown condition of the pipe through the levee. (O. Magana - DWR UCIP)

01/16/2017 - Landowner who utilizes this pipe reported to RD784 staff on 1/11/2017 that he suspected this pipe at the waterside flap gate ring area was rusted out at the bottom. After investigating, we could see what was reported is correct. Sandbags have been temporarily placed around the 2" +/- gapped area underneath the flap gate ring. A permanent solution is anticipated to be completed in the next 3 to 6 months. The plan is to pour a concrete ring / headwall around the open corroded pipe end. Photos attached. (P. Meagher - RD784).

Close up photo of concrete seal where the rusted out void used to be. Farmer irrigation was currently flowing at the time the photo was taken.

11/30/2017 Crossing remains Urgent due to uncertainty of pipe condition through levee -- recommend an internal inspection of the pipe through the levee as a precaution measure to determine integrity of pipe. Repair of the rusted out collar (void) found at the WS pipe outlet has been repaired by the LMA. Received additional photos from DWR levee inspector, S. York, of the WS concrete headwall installed and vegetation cleared from WS. (O. Magana - DWR UCIP)

07/13/2017 - The rusted out collar at the bottom of the waterside flap gate has been sealed with concrete. Internal pipe inspections still pending. (P.Meagher-RD784).

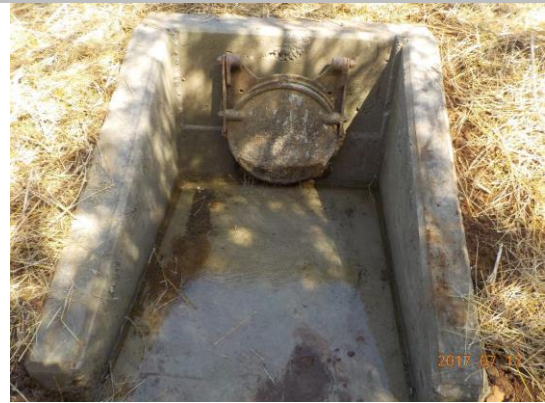
Photo 2 of 3 : UCIP_FA_2019_53072_77115.jpg

Concrete collar completed around the waterside exterior flap gate section.

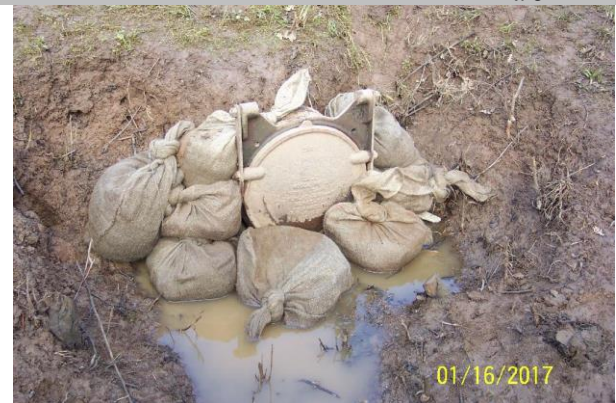
Photo 3 of 3 : UCIP_FA_2019_53072_76618.jpg

Sandbags temporarily placed in front of flapgate.

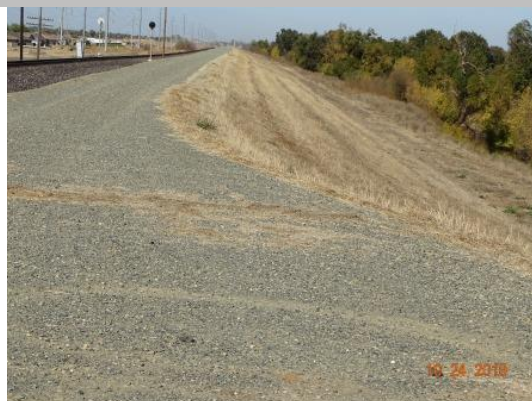
Photo 1 of 1 : FA_2019_RD0784_181_3_20191029_00007.jpg

View looking downstream waterside at the well maintained annual vegetation, Fall 2019.

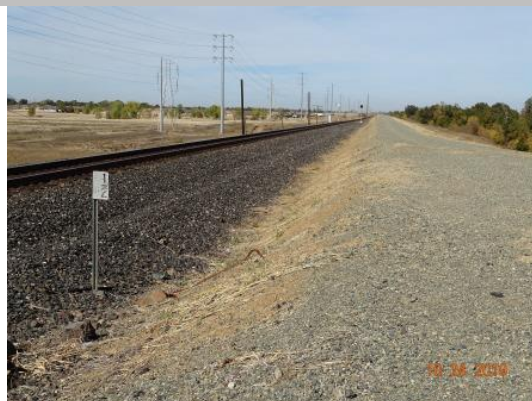
Photo 1 of 1 : FA_2019_RD0784_181_2_20191029_00006.jpg

View looking downstream landside at the well maintained annual vegetation, Fall 2019.

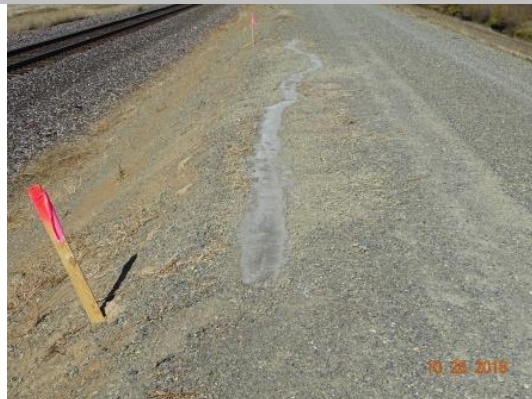
Photo 1 of 1 : FA_2019_RD0784_181_4_20190904_00001.jpg

View looking upstream on the crown of lineal cracking that has been repaired, Fall 2018.

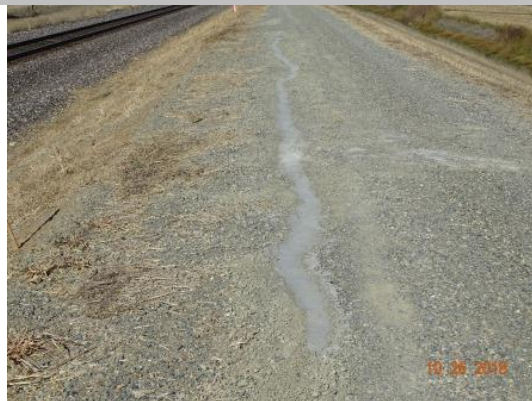
Photo 1 of 1 : FA_2019_RD0784_181_5_20190904_00002.jpg

View looking upstream on the crown of lineal cracking that has been repaired, Fall 2018.

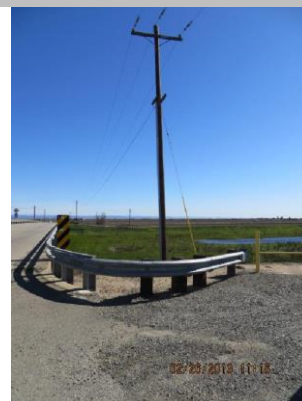
Photo 1 of 3 : UCIP_FA_2019_46600_54244.jpg

Communication line at base of JP on WS slope.

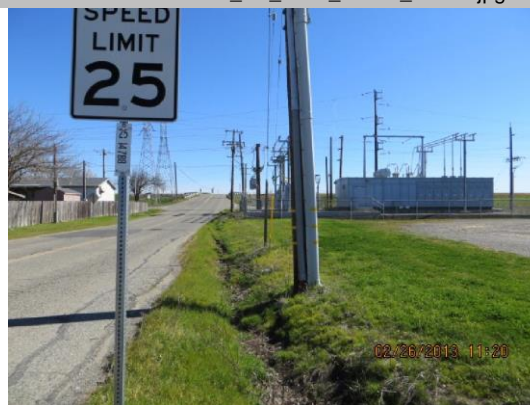
Photo 2 of 3 : UCIP_FA_2019_46600_54243.jpg

Communication line runs on south side of Plumas Arboga Road to JP approximately 400-feet West of levee crown.

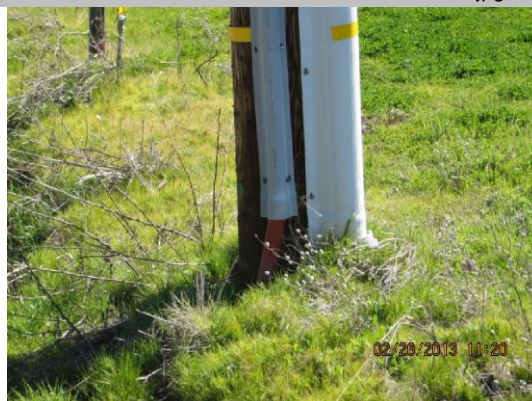
Photo 3 of 3 : UCIP_FA_2019_46600_54242.jpg

Communication line runs on south side of Plumas Arboga Road to JP approximately 400-feet West of levee crown.

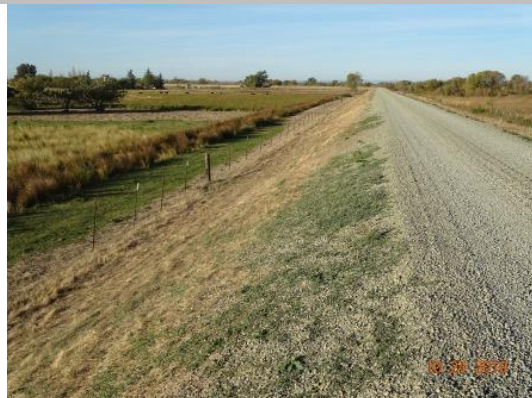
Photo 1 of 1 : FA_2019_RD0784_182_14_20191029_00032.jpg

View looking downstream landside at the well maintained annual vegetation, Fall 2019.

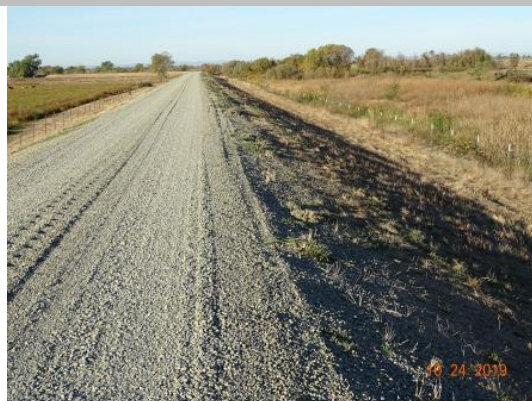
Photo 1 of 1 : FA_2019_RD0784_182_15_20191029_00033.jpg

View looking downstream waterside at the well maintained annual vegetation, Fall 2019.

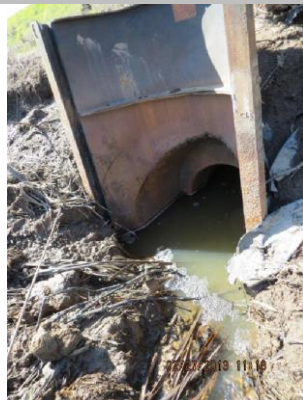
Photo 1 of 3 : UCIP_FA_2019_53544_16552.jpg

inlet control structure on LS toe.

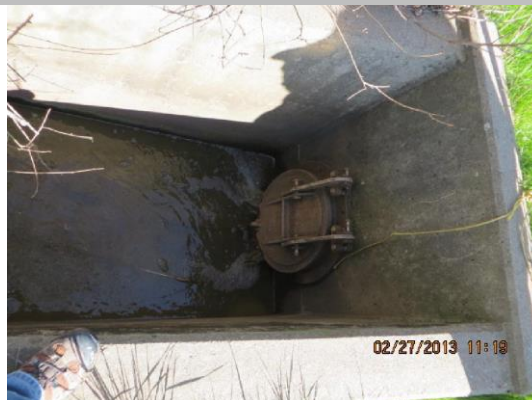
Photo 2 of 3 : UCIP_FA_2019_53544_16555.jpg

Concrete U-shaped outlet with flap gate on WS toe.

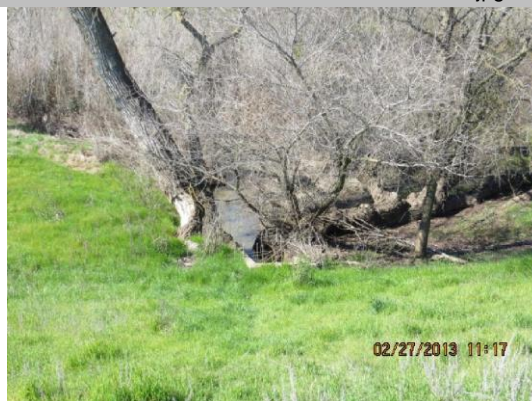
Photo 3 of 3 : UCIP_FA_2019_53544_16554.jpg

Concrete U-shaped outlet on WS toe.

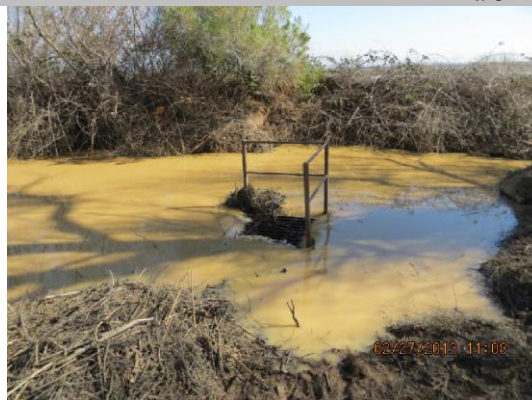
Photo 1 of 2 : UCIP_FA_2019_53546_54246.jpg

Concrete drop-inlet at LS toe.

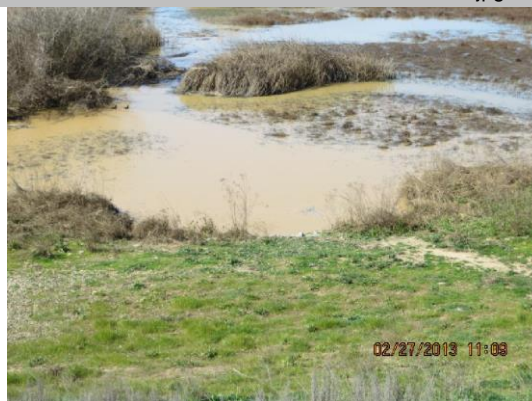
Photo 2 of 2 : UCIP_FA_2019_53546_54245.jpg

Outlet with riprap on WS toe.

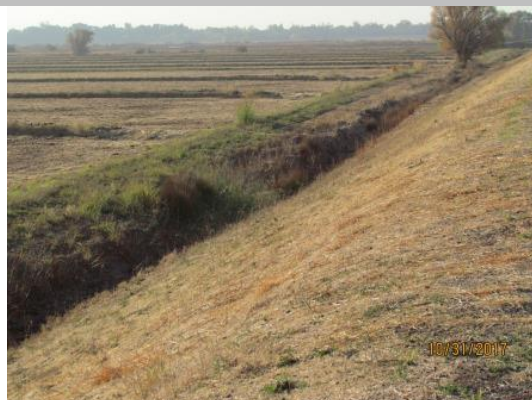
Photo 1 of 1 : FA_2019_RD0784_182_10_20190904_00003.jpg

View of landside looking downstream at the ditch that is along the levee toe.

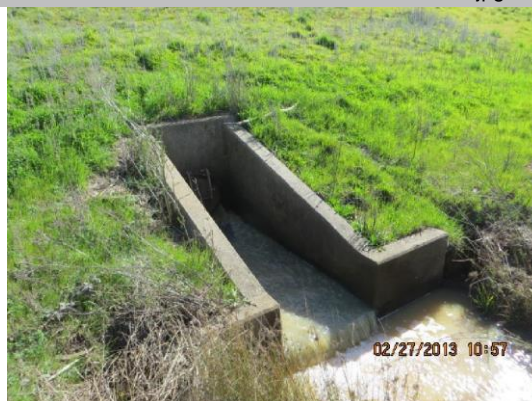
Photo 1 of 3 : UCIP_FA_2019_53547_16565.jpg

Concrete U-shaped headwall and flap gate on WS toe.

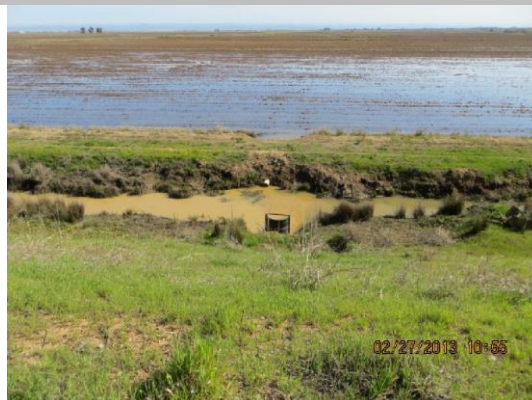
Photo 2 of 3 : UCIP_FA_2019_53547_16563.jpg

Pvc weir on inlet at LS toe.

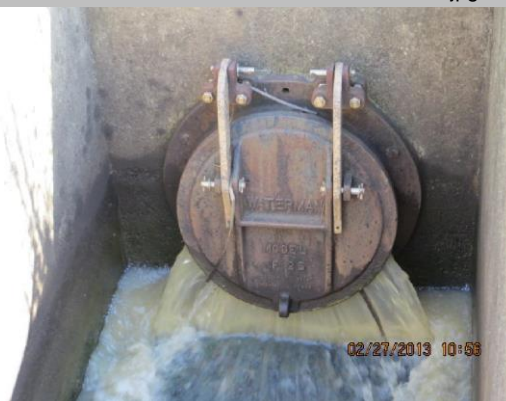
Photo 3 of 3 : UCIP_FA_2019_53547_16562.jpg

Concrete U-shaped headwall and flap gate on WS toe.

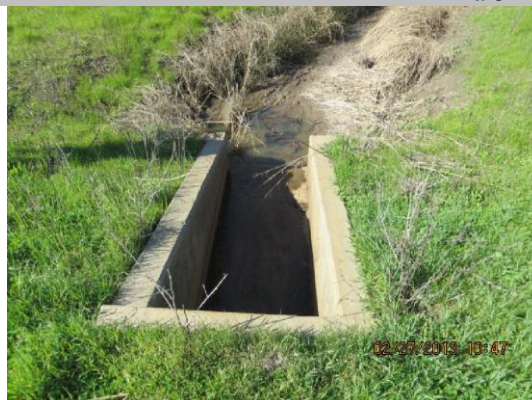
Photo 1 of 3 : UCIP_FA_2019_53548_54247.jpg

Concrete U-shaped outlet and flap-gate on WS toe.

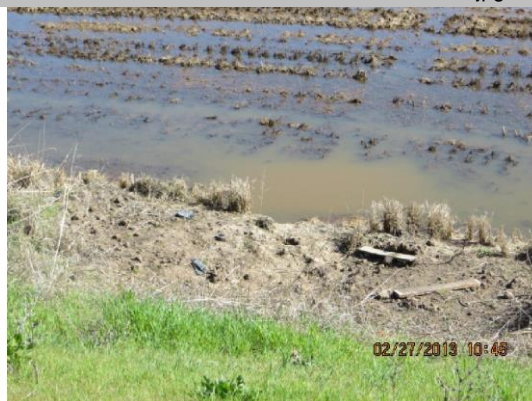
Photo 2 of 3 : UCIP_FA_2019_53548_54248.jpg

Debris covered inlet on LS toe.

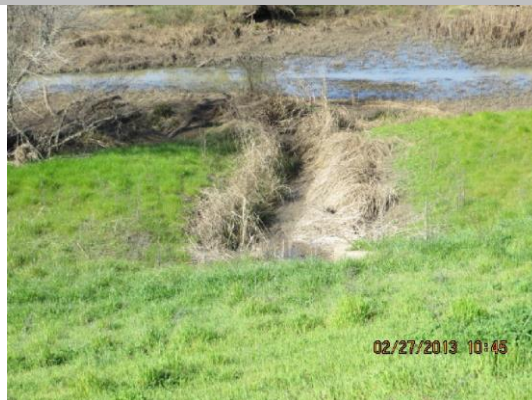
Photo 3 of 3 : UCIP_FA_2019_53548_54249.jpg

Drainage outlet on WS toe.

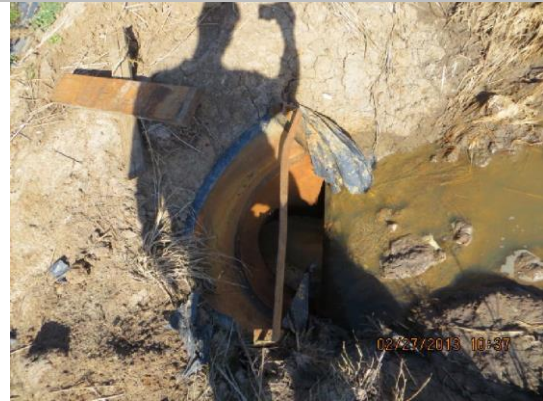
Photo 1 of 3 : UCIP_FA_2019_53557_54250.jpg

Inlet with PVC weir on LS toe.

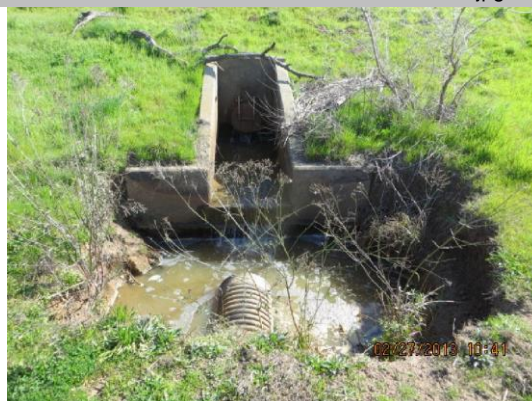
Photo 2 of 3 : UCIP_FA_2019_53557_54253.jpg

Concrete U-shaped headwall on WS toe with Flap gate showing erosion at outlet.

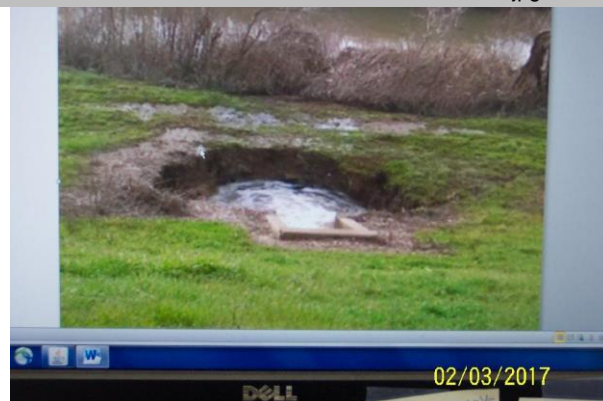
Photo 3 of 3 : UCIP_FA_2019_53557_76774.jpg

After photo after excess pipe was cut off. Actual photo date was 1/31/2017

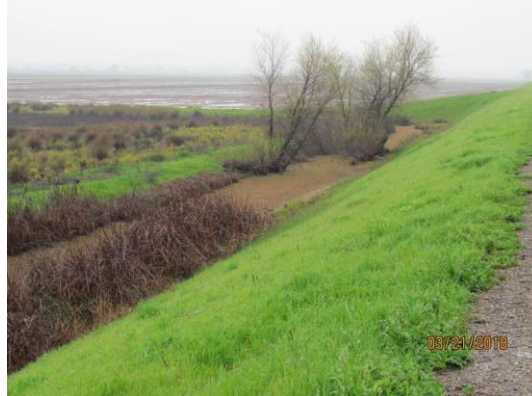
Photo 1 of 1 : FA_2019_RD0784_182_9_20190904_00002.jpg

View of landside looking downstream at the ditch that is along the levee toe.

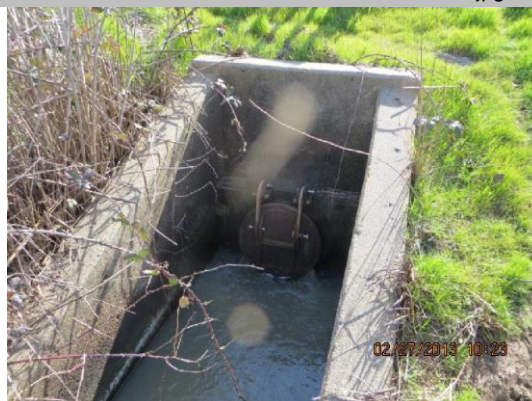
Photo 1 of 3 : UCIP_FA_2019_56031_54258.jpg

Concrete U-shaped headwall and flap gate on WS toe.

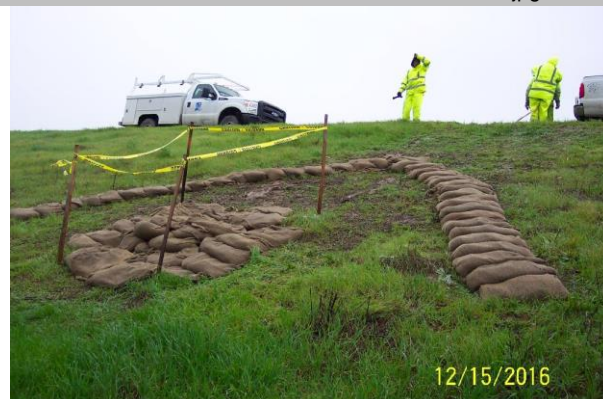
Photo 2 of 3 : UCIP_FA_2019_56031_76309.jpg

WS view: Sink hole filled in with sandbags and "V" shaped diversion dam built to help divert rainwater.

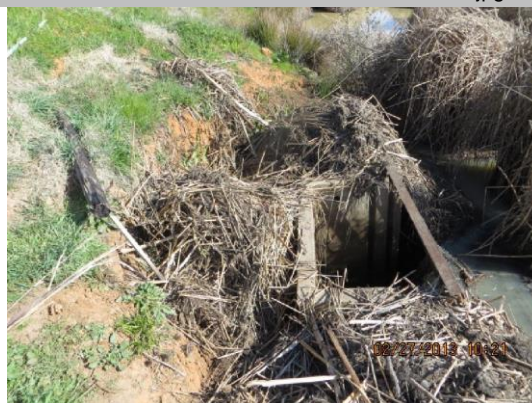
Photo 3 of 3 : UCIP_FA_2019_56031_54254.jpg

Erosion and debris from Beaver activity.

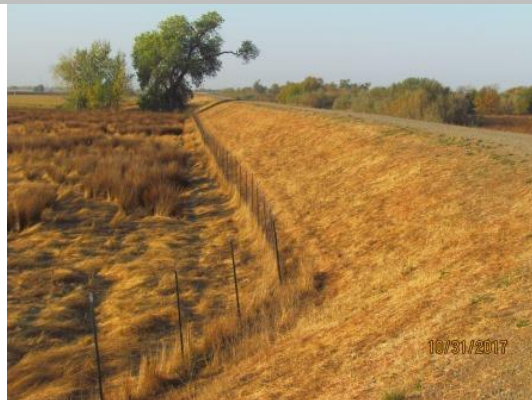
Photo 1 of 1 : FA_2019_RD0784_182_5_20190904_00001.jpg

View of fence along the landside toe looking downstream.

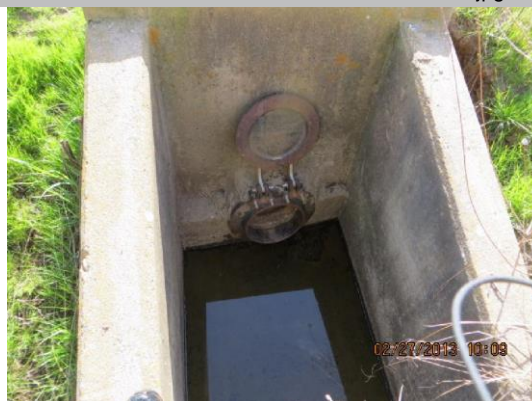
Photo 1 of 3 : UCIP_FA_2019_53553_54259.jpg

Concrete U-shaped headwall and flap gate on WS toe.

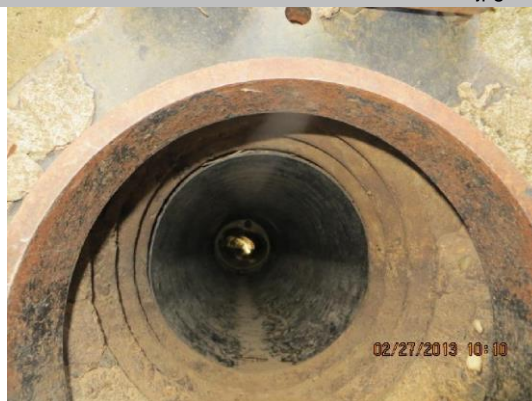
Photo 2 of 3 : UCIP_FA_2019_53553_54262.jpg

Pipe showing sliplined PVC insert. some erosion of PV at outlet and it may be disjointed internally.

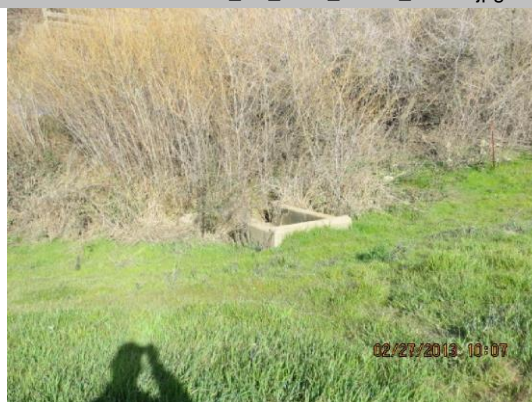
Photo 3 of 3 : UCIP_FA_2019_53553_54261.jpg

Concrete U-shaped headwall on WS toe.

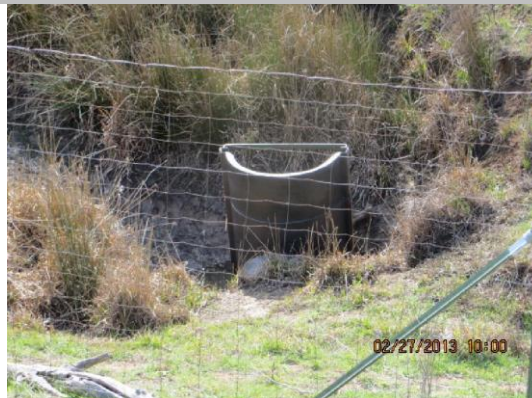
Photo 1 of 2 : UCIP_FA_2019_53552_16594.jpg

PVC weir inlet on LS toe.

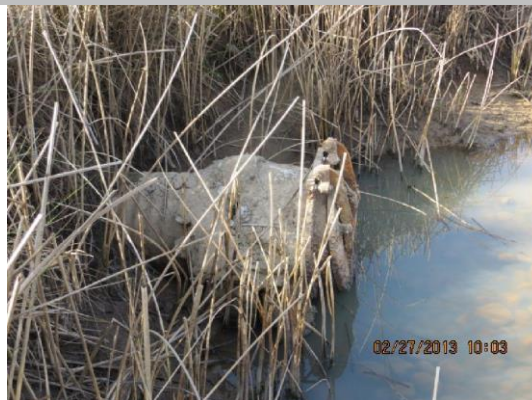
Photo 2 of 2 : UCIP_FA_2019_53552_16593.jpg

Flap gate at WS toe.

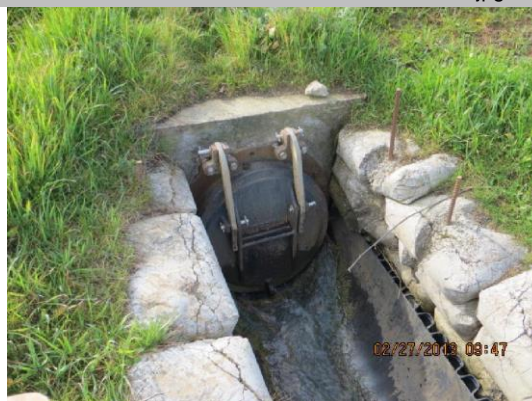
Photo 1 of 3 : UCIP_FA_2019_53551_16590.jpg

Concrete outlet and flap gate on WS toe.

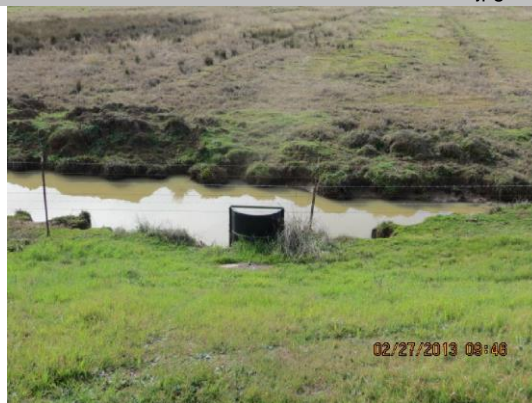
Photo 2 of 3 : UCIP_FA_2019_53551_16591.jpg

PVC weir at inlet on LS toe.

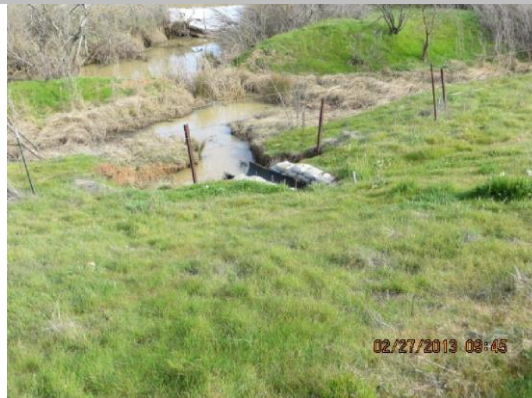
Photo 3 of 3 : UCIP_FA_2019_53551_16592.jpg

Concrete outlet on WS toe.

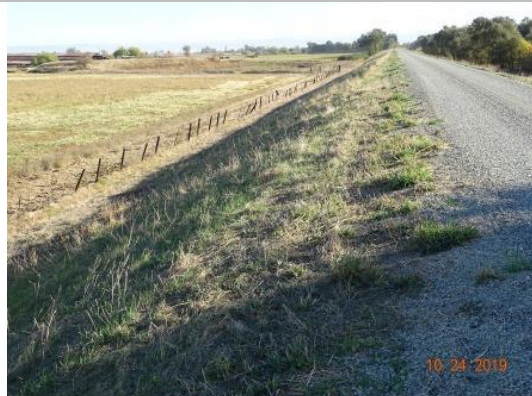
Photo 1 of 1 : FA_2019_RD0784_183_2_20191029_00005.jpg

View looking downstream landside at the well maintained annual vegetation, Fall 2019.

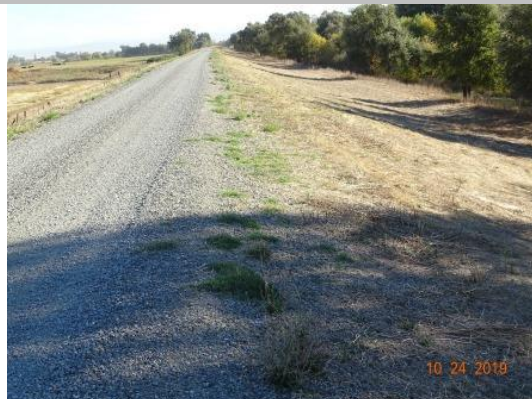
Photo 1 of 1 : FA_2019_RD0784_183_3_20191029_00004.jpg

View looking downstream waterside at the well maintained annual vegetation, Fall 2019.

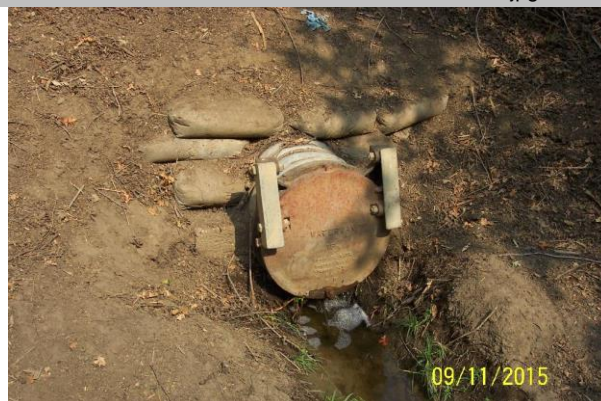
Photo 1 of 3 : UCIP_FA_2019_53542_74682.jpg

Flap Gate is clear as of 9/11/15.

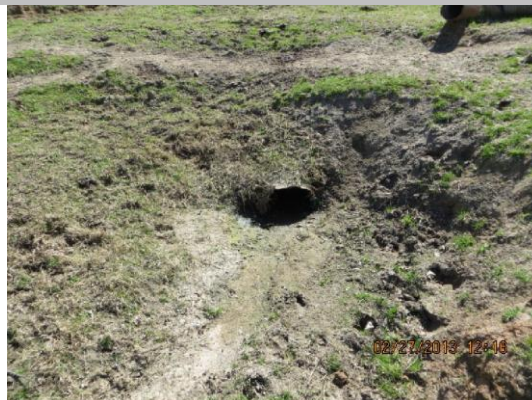
Photo 2 of 3 : UCIP_FA_2019_53542_54268.jpg

Partially clogged inlet pipe at LS toe.

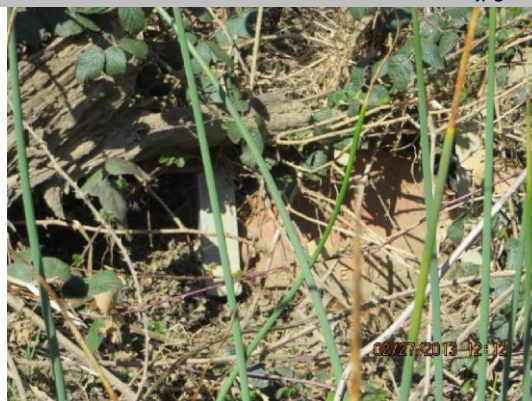
Photo 3 of 3 : UCIP_FA_2019_53542_54265.jpg

Flap gate blocked by vegetation at WS.

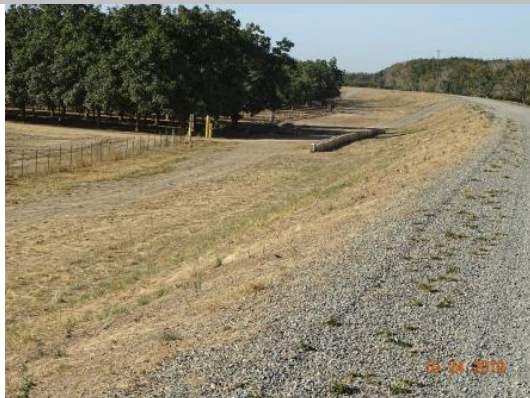
Photo 1 of 1 : FA_2019_RD0784_184_1_20191029_00003.jpg

View looking downstream landside at the well maintained annual vegetation, Fall 2019.

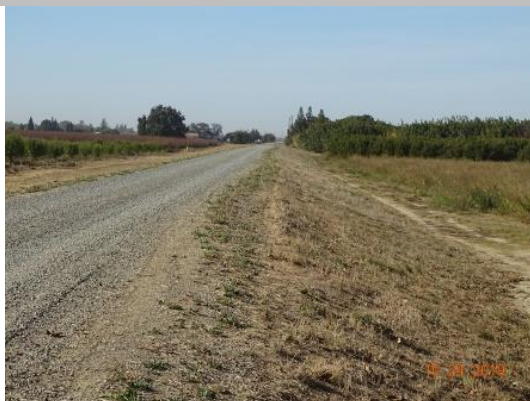
Photo 1 of 1 : FA_2019_RD0784_184_2_20191029_00002.jpg

View looking downstream waterside at the well maintained annual vegetation, Fall 2019.

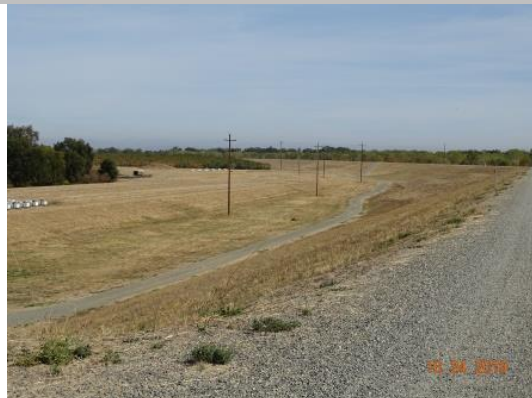
Photo 1 of 1 : FA_2019_RD0784_437_1_20191029_00001.jpg

View looking downstream landside at the well maintained annual vegetation, Fall 2019.

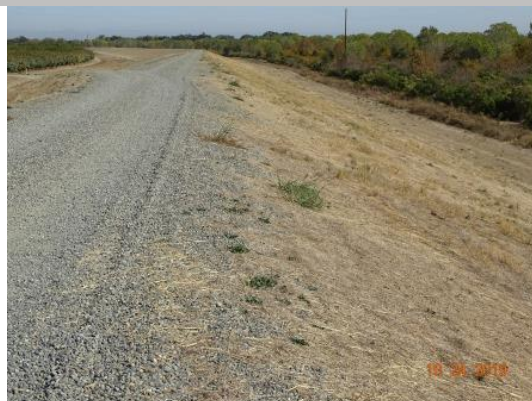
Photo 1 of 1 : FA_2019_RD0784_437_2_20191029_00002.jpg

View looking downstream waterside at the well maintained annual vegetation, Fall 2019.

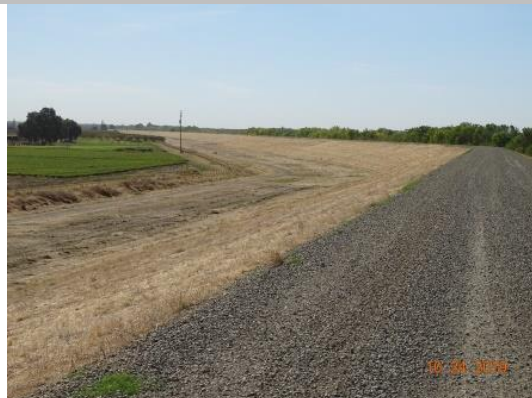
Photo 1 of 1 : FA_2019_RD0784_530_1_20191029_00001.jpg

View looking downstream landside at the well maintained annual vegetation, Fall 2019.

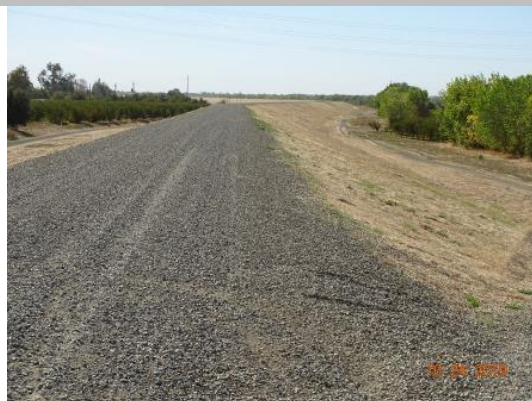
Photo 1 of 1 : FA_2019_RD0784_530_2_20191029_00002.jpg

View looking downstream waterside at the well maintained annual vegetation, Fall 2019.
